Structural Assessment – Existing Condition Report

Project #21RS-0851
February 16th, 2022

*Sea Shell Condominium Association,
Inc.
6500 Midnight Pass Road
Sarasota, FL 34242*

*RE: Sea Shell - Existing Condition Survey
6500 Midnight Pass Road, Sarasota, FL 34242
KEG File# 21RS-0851*

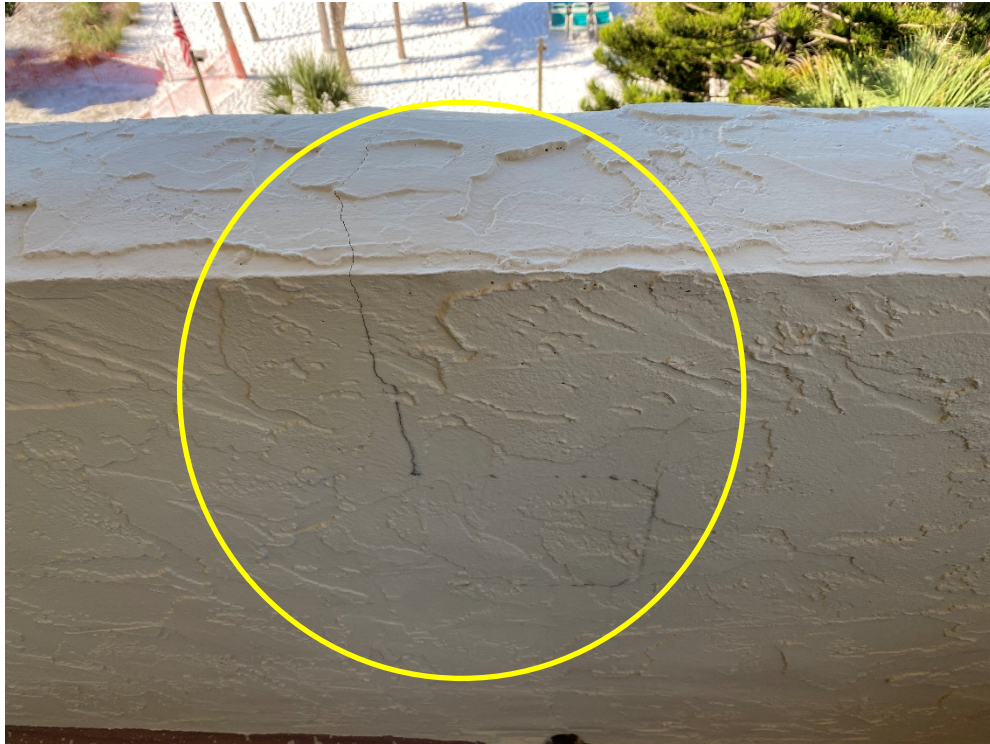
Figure 1. HLC on balcony knee wall

HLC, small and medium cracks are observed by KEG at some locations on the balconies, walkways and walls. KEG does not believe this is of major concern but recommends the unit owner to periodically observe if the crack become wider and longer. Please report to Engineer as needed.

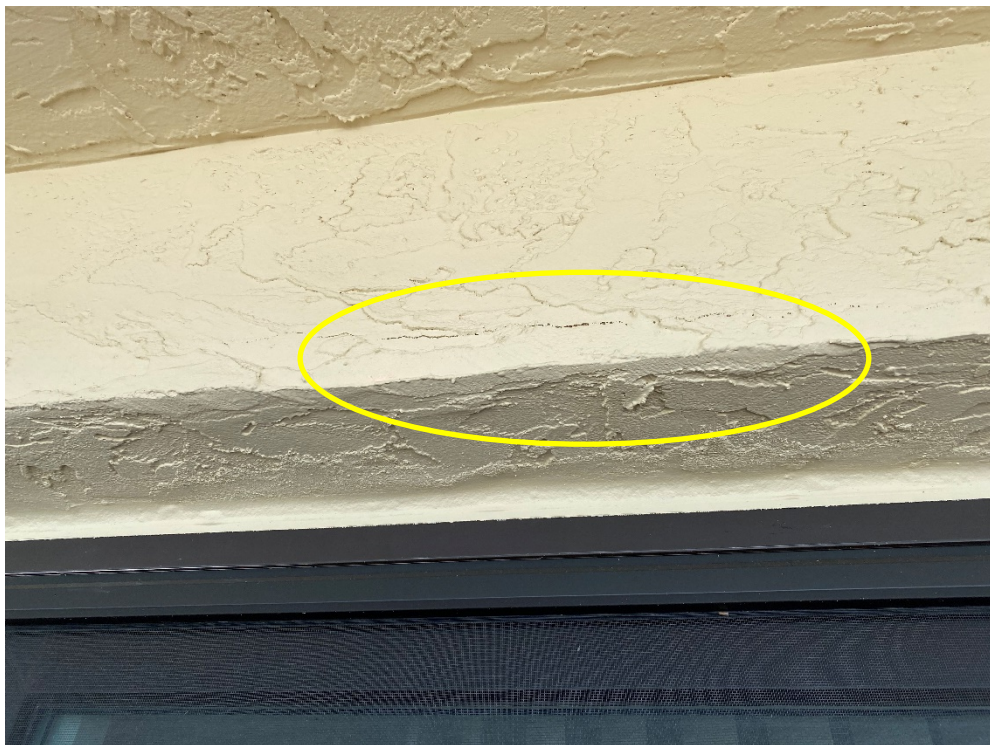
Figure 2. Spalling observed over the sliding glass doors

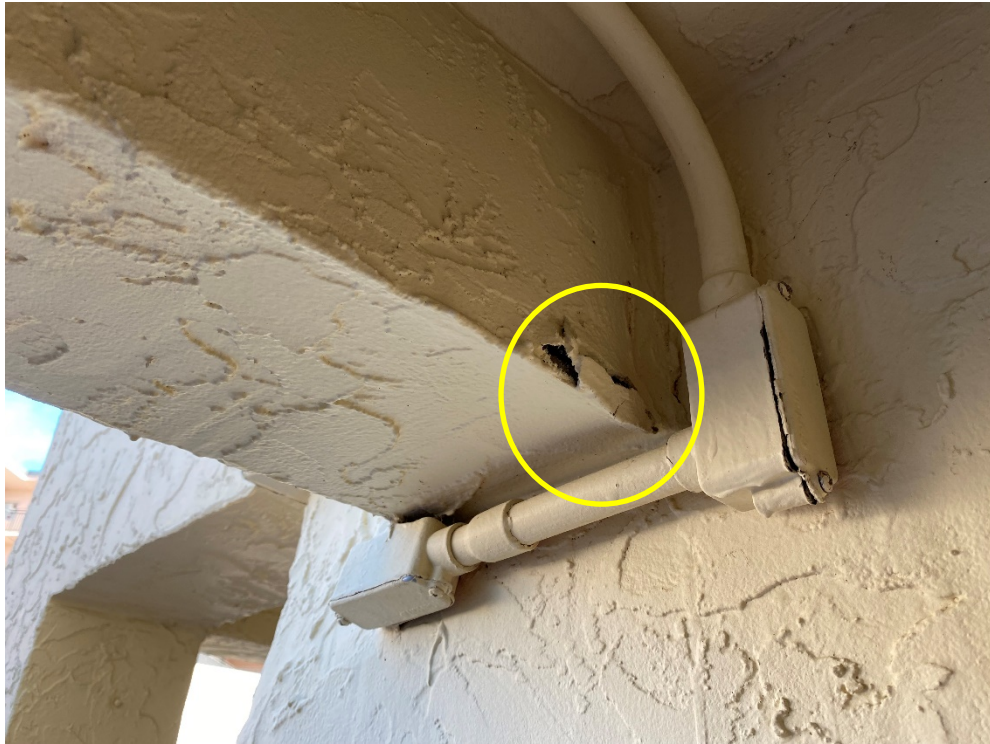
Figure 3. Minor Spall on beam in Garage/Carport

Karins observed areas of concern on some of the ground level beams. Minor signs of spalling is observed on the beams throughout the building. Spalls should be repaired as soon as possible but does not put a threat to the integrity of the structure.

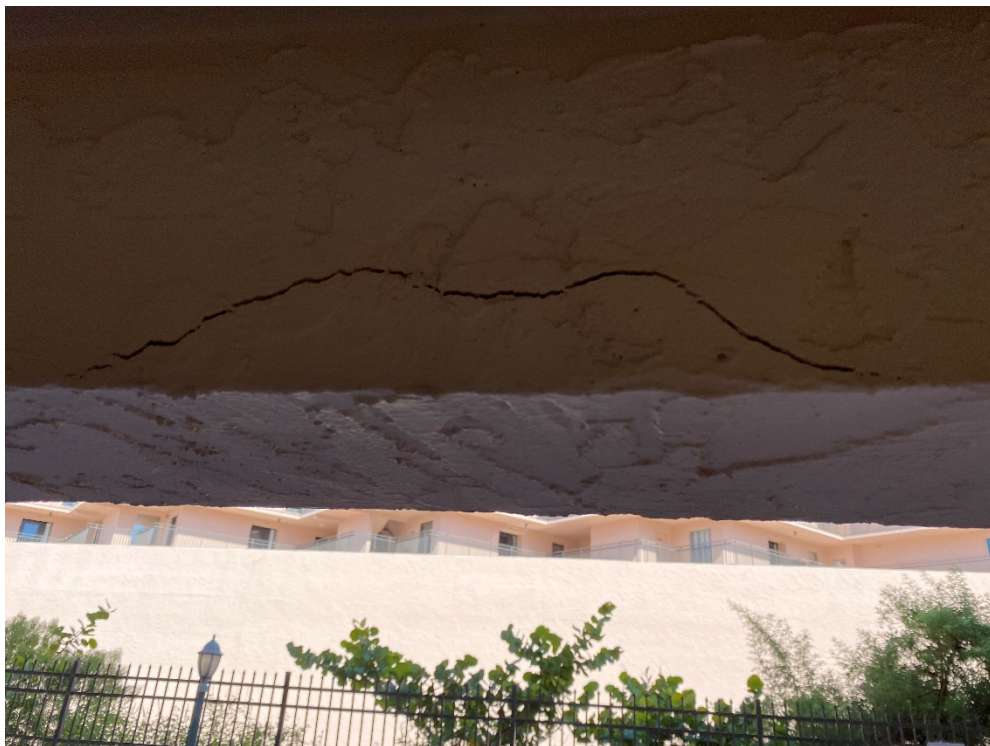
Figure 4. Beam Spall in Garage /Carport

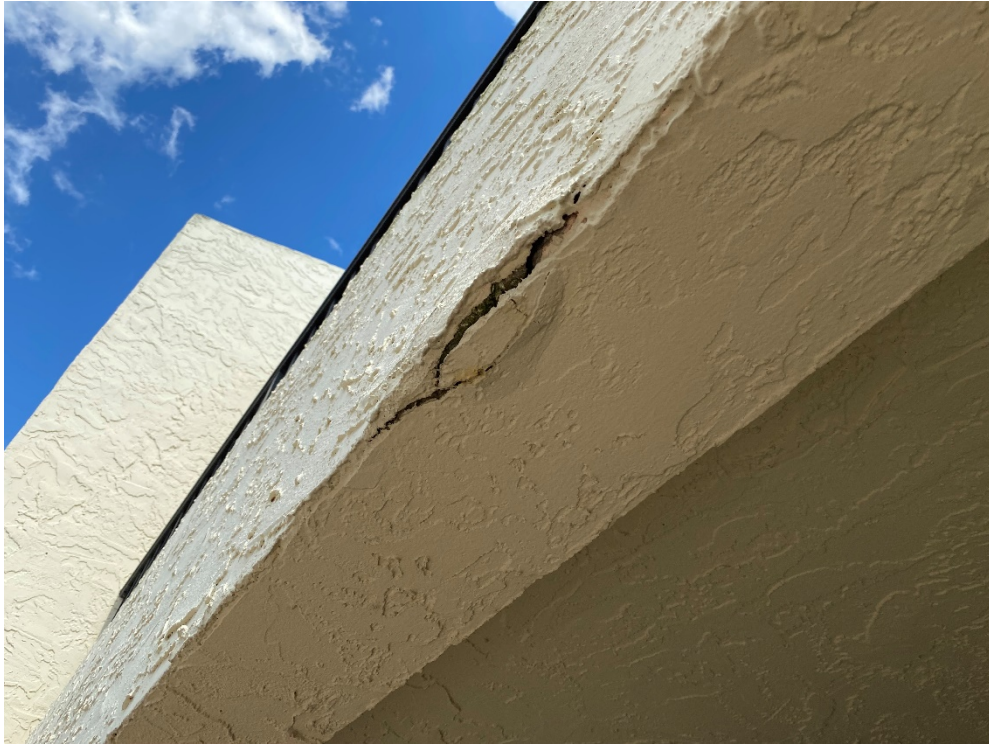
Figure 5. Beam Spalling

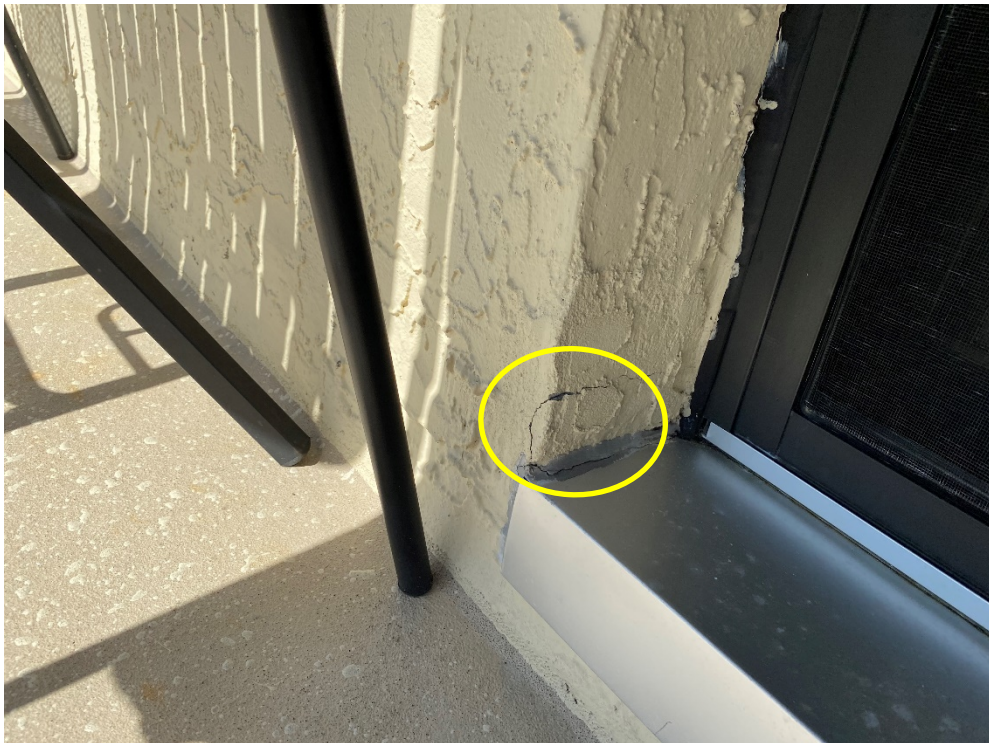
Figure 6. Medium Crack – Potential spall

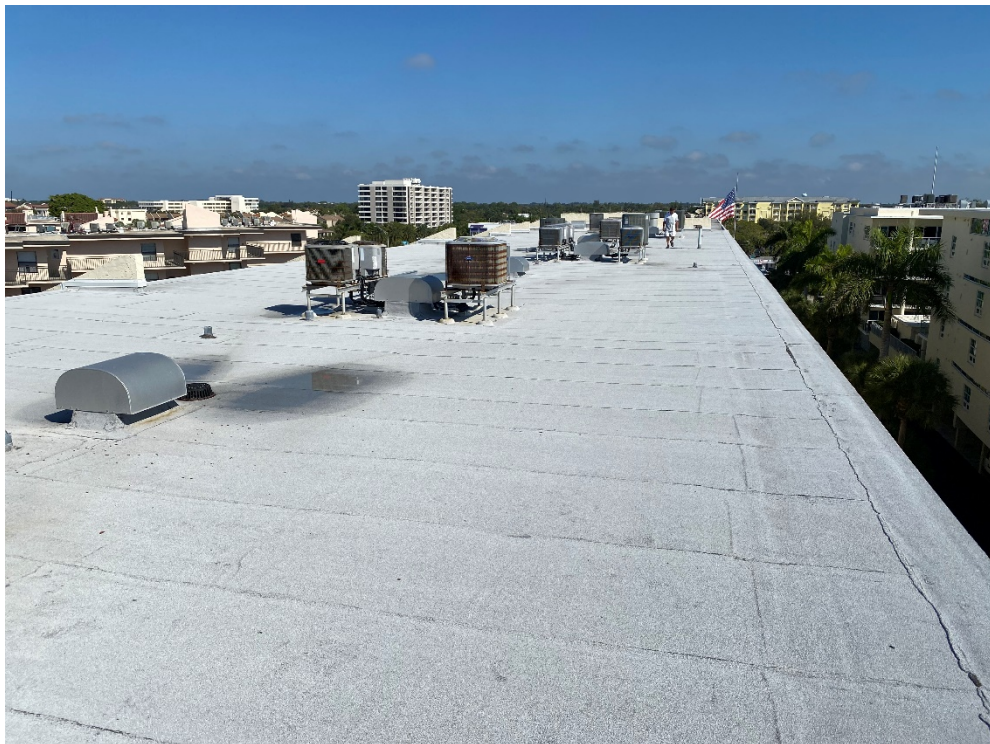
Figure 7. General View of the modified bitumen Roofing System

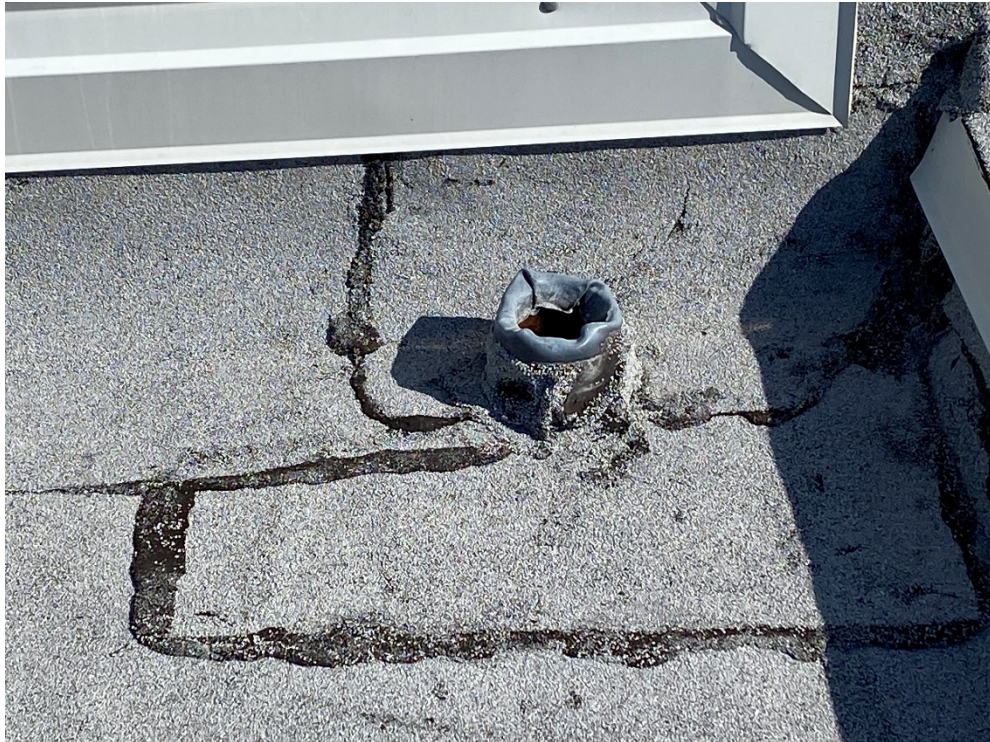
Figure 8. Boot vent extends less than 6" above roof line

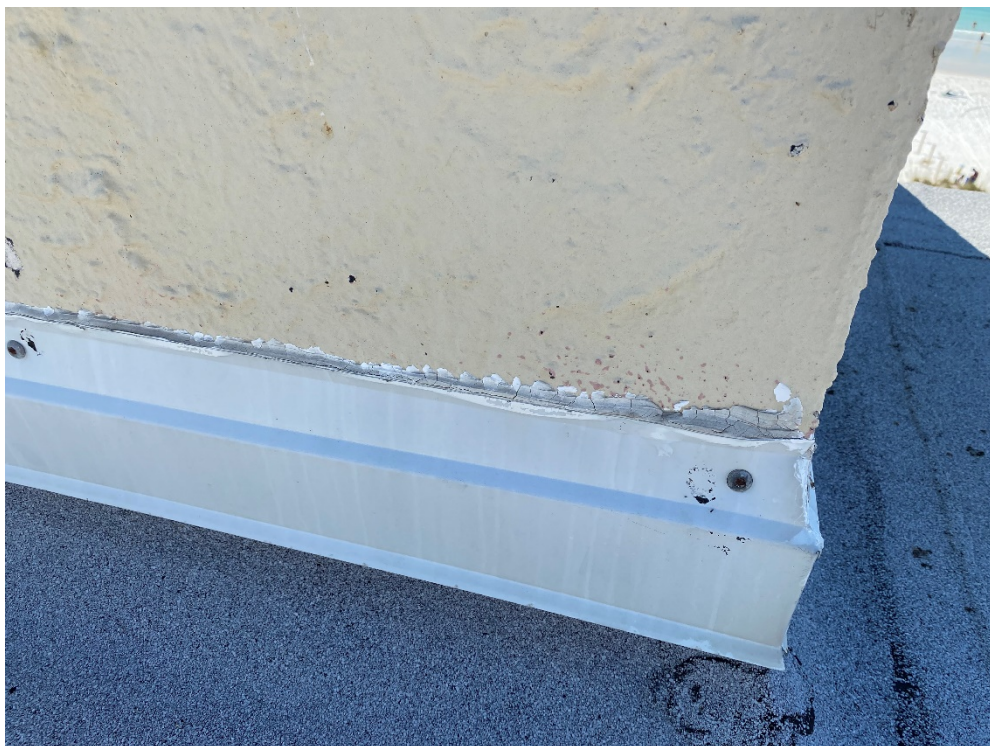
Figure 9. Sealant at counter-flashing is cracking throughout the perimeter of the roof

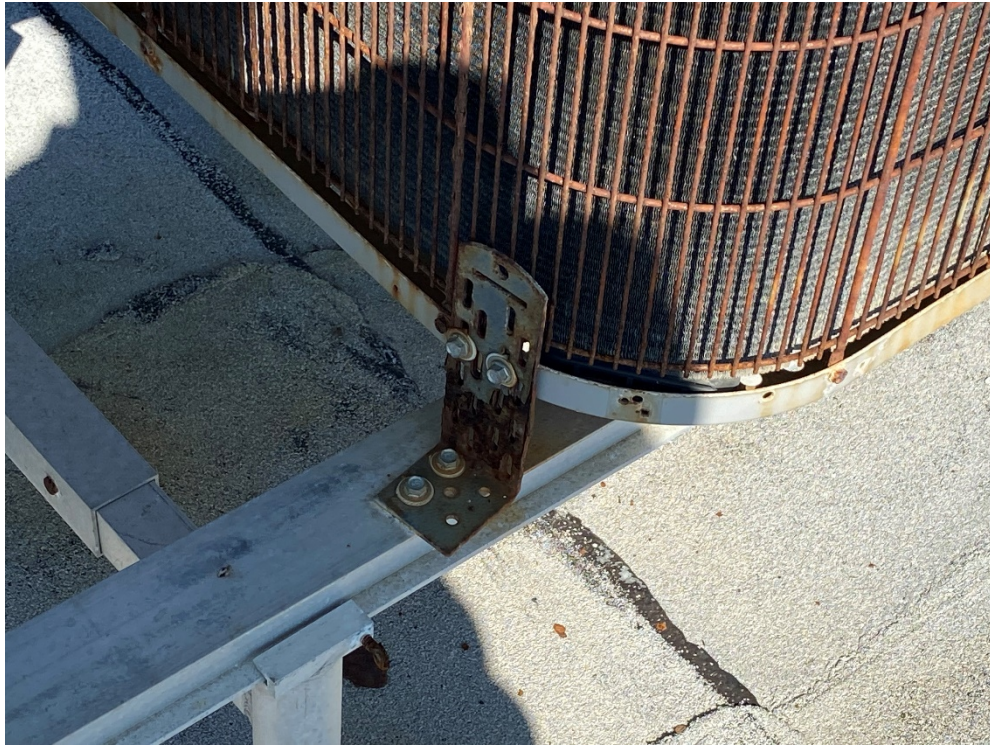
Figure 10. Aluminum Stands connection to condenser units up to current codes

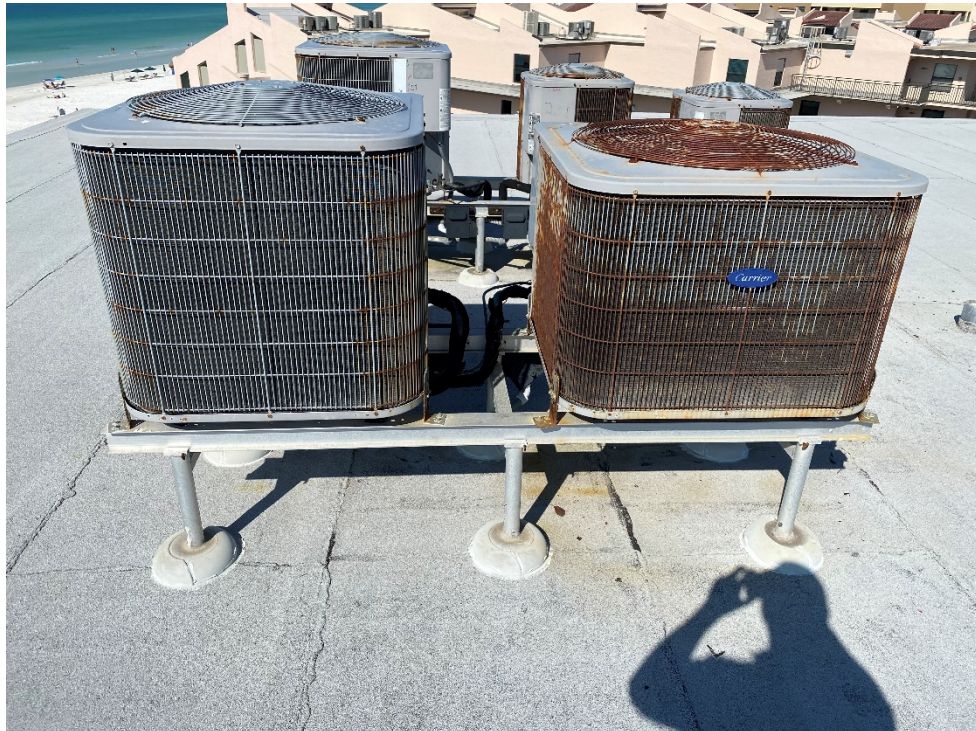
Figure 11. A/C stands on West side of the roof are meeting current code

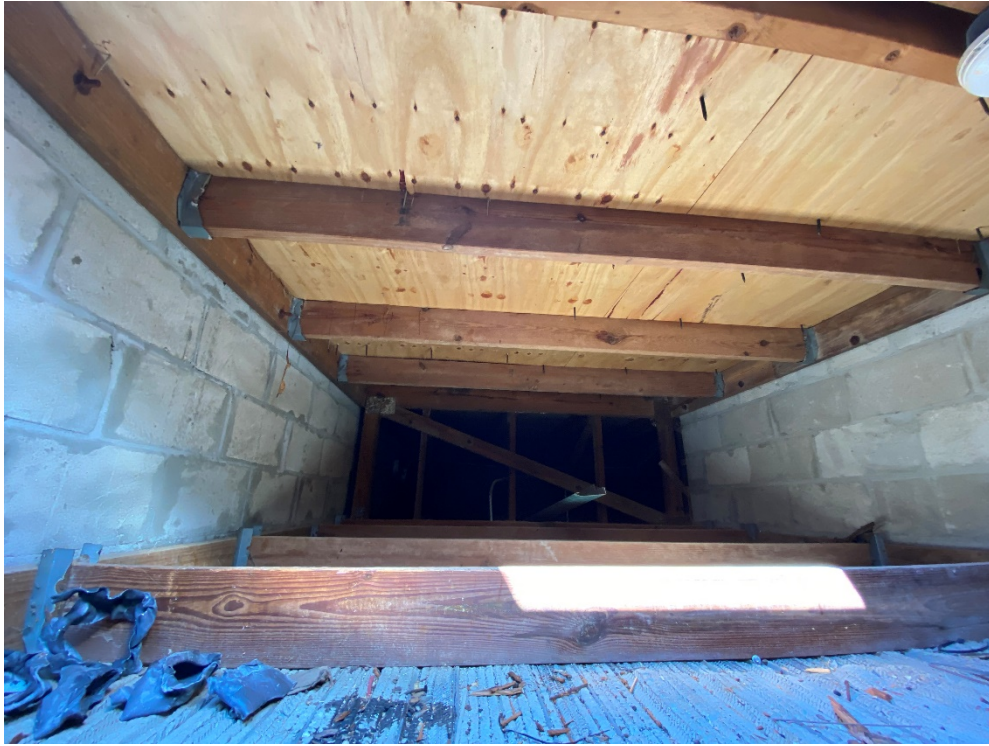
Figure 1. Sheathing roof deck appears to be in good condition

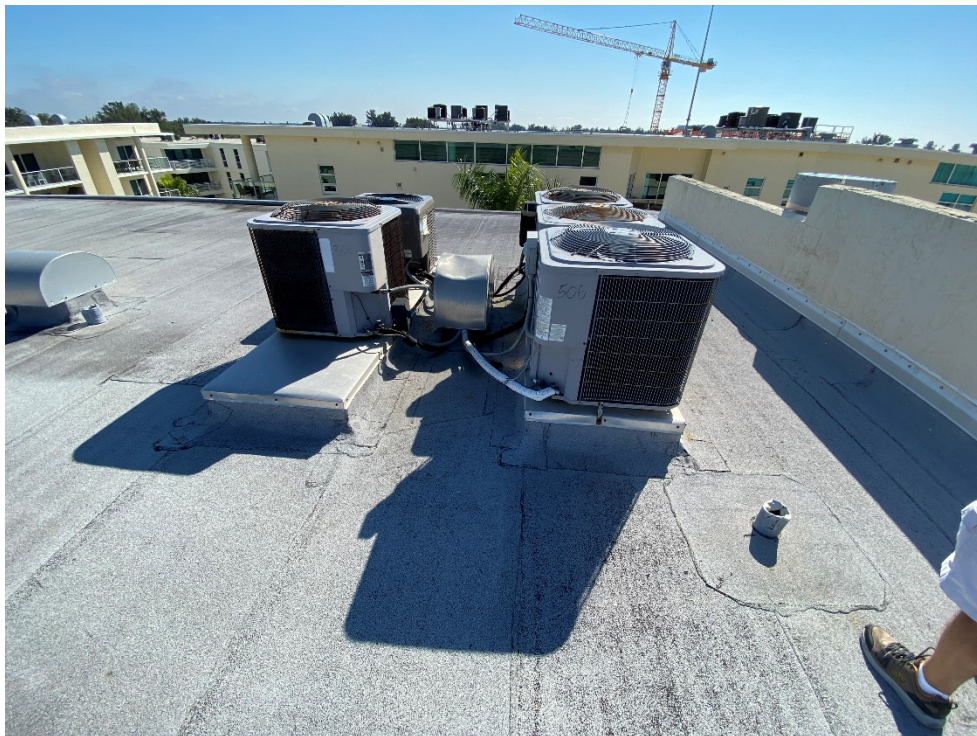
Figure 2. A/C curbs on East side of the roof does not meeting current code

2. The current modified bitumen roof appears to be in good condition. A/C stands are up to code and minimal ponding is observed at the time of inspection. A/C roof curbs on the East side of the roof are not code compliant and will need to be replaced with aluminum stands on the next roofing project. Sealant at the counter flashing is recommended to be removed and replace as soon as possible. Granules are starting to detach from the bitumen, acute maintenance check should be done periodically to avoid water intrusion.

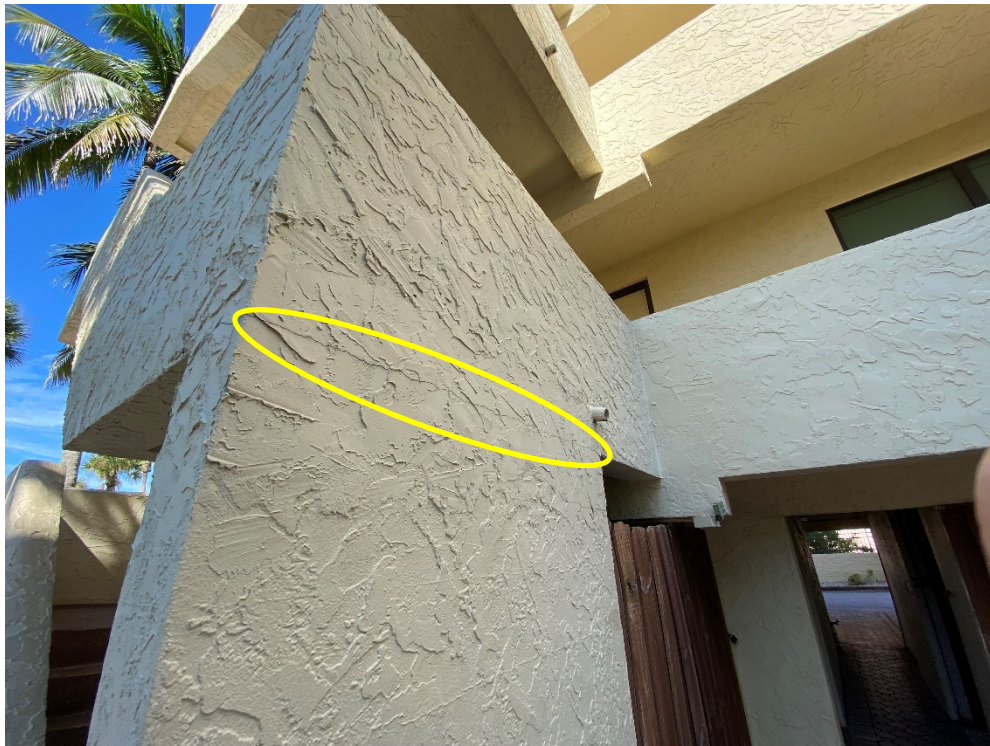
Figure 14. Typical Stucco Hair Line Crack

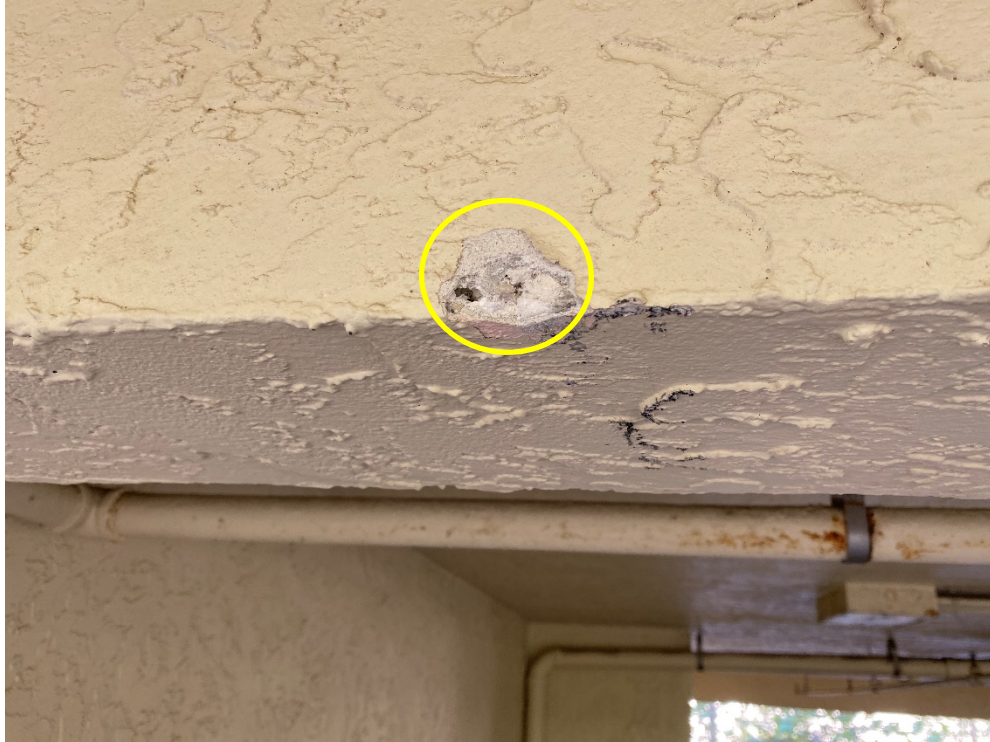
Figure 15. Stucco damage from vehicular impact

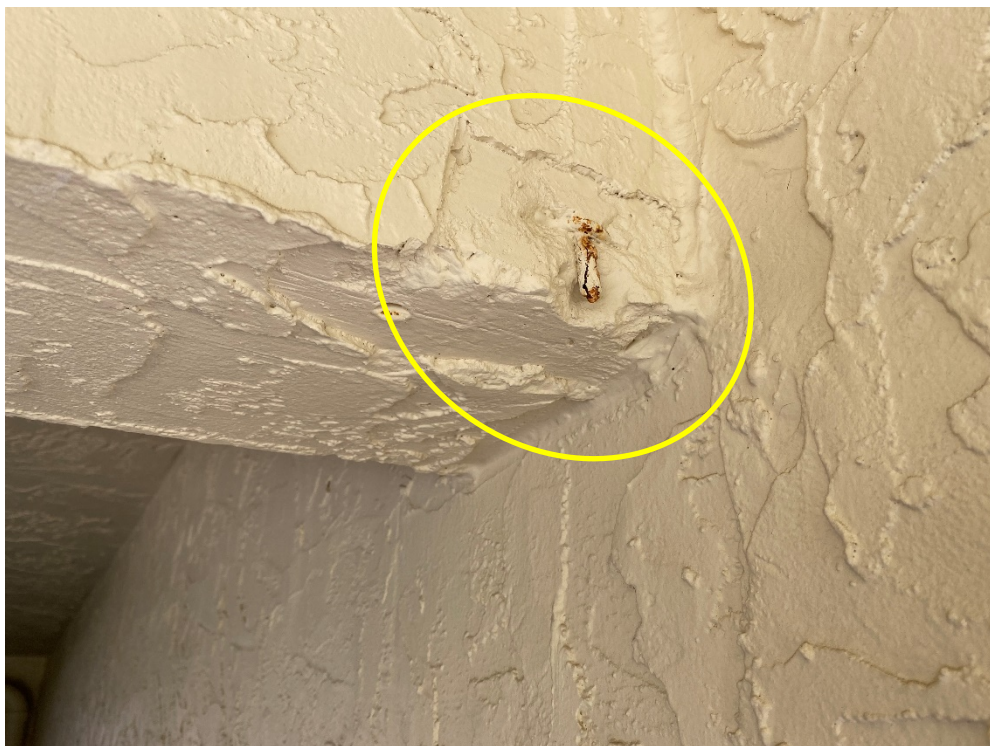
Figure 16. Corroding rebar support chair without enough clearance

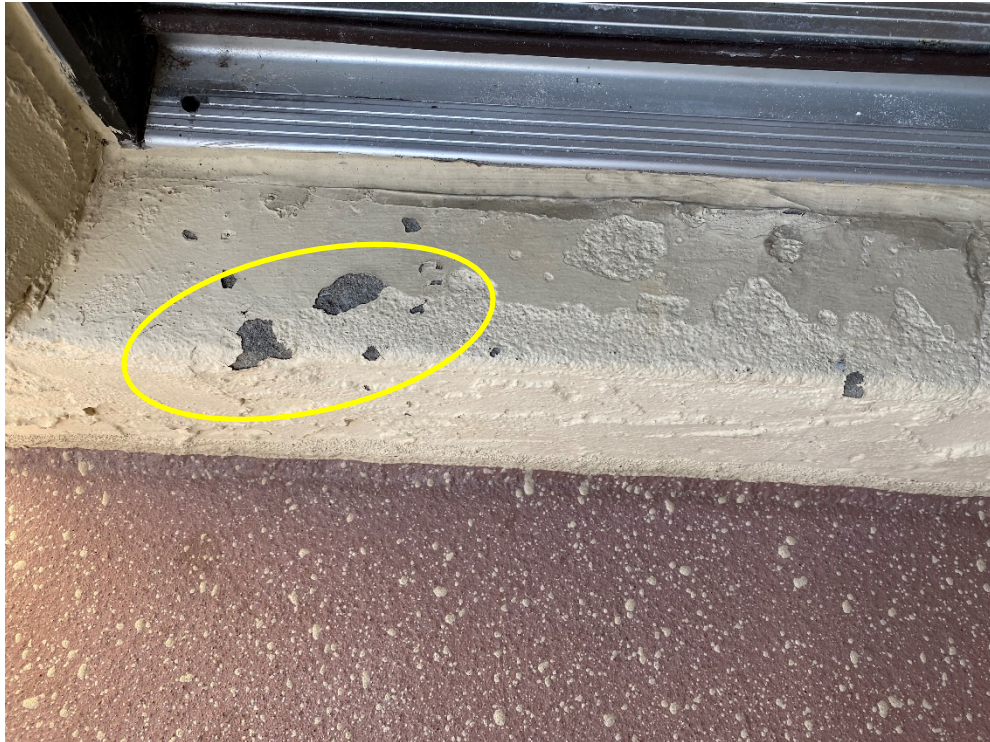
Figure 17. Paint Peeling and flaking

5. Develop and adhere to a strict painting/sealant cycle to ensure the protection of the exterior building envelope and its components. KEG recommends repainting/resealing the building every 7 to 10 years depending on the quality of paint chosen. The next painting project is thus expected in 2024.

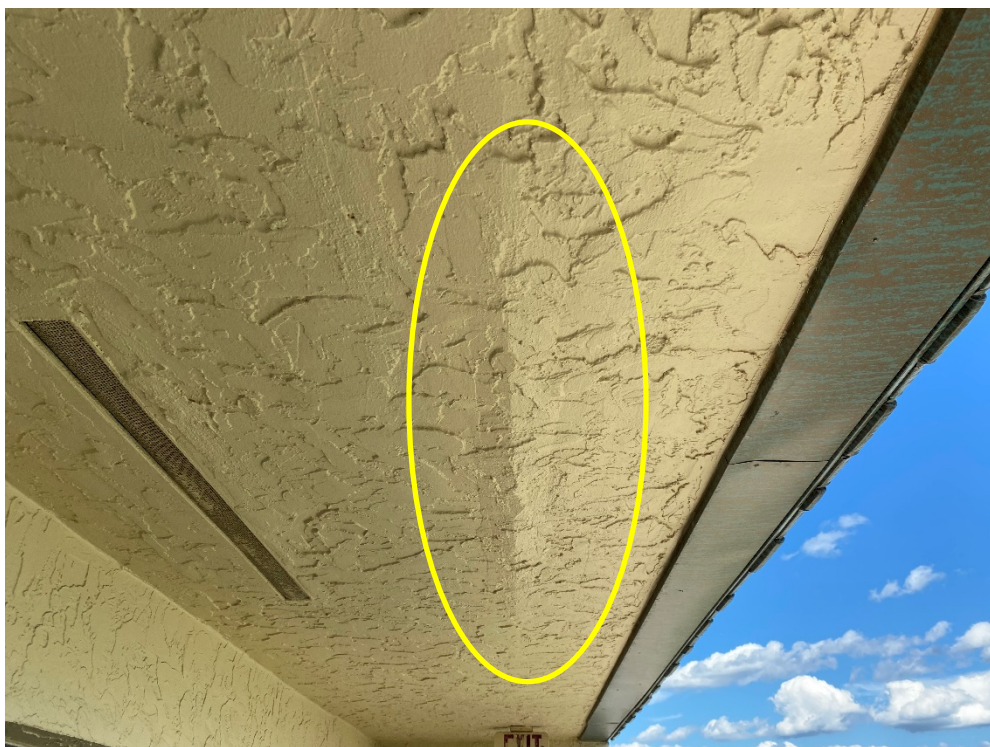
Figure 18. Stucco delamination

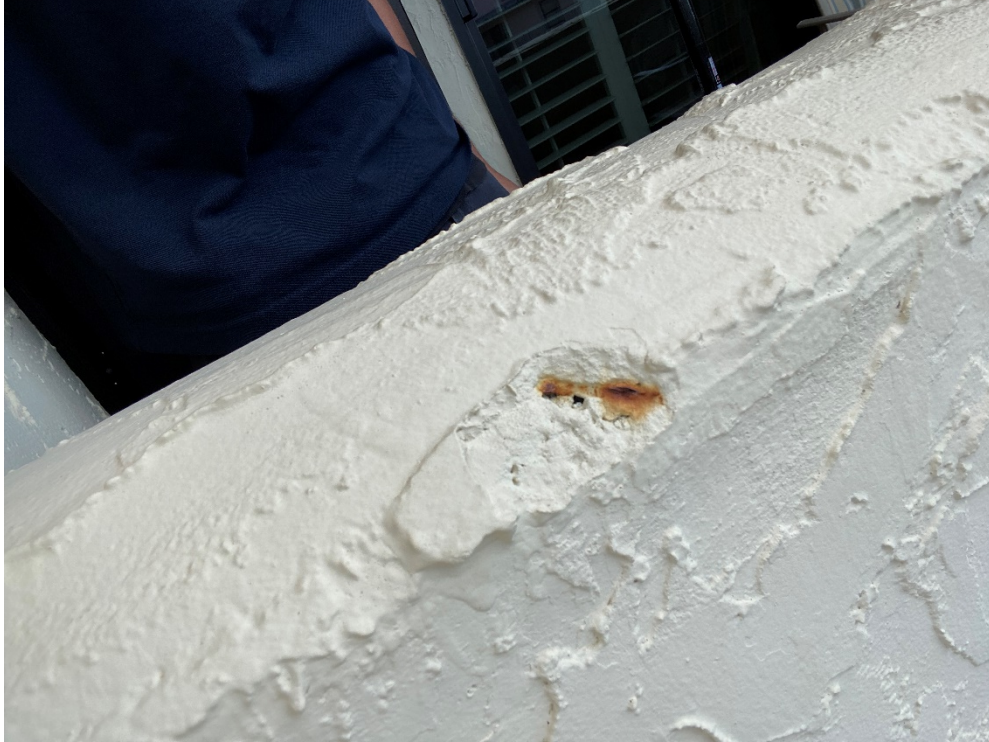
Figure 19. Rust spot on walkways knee wall

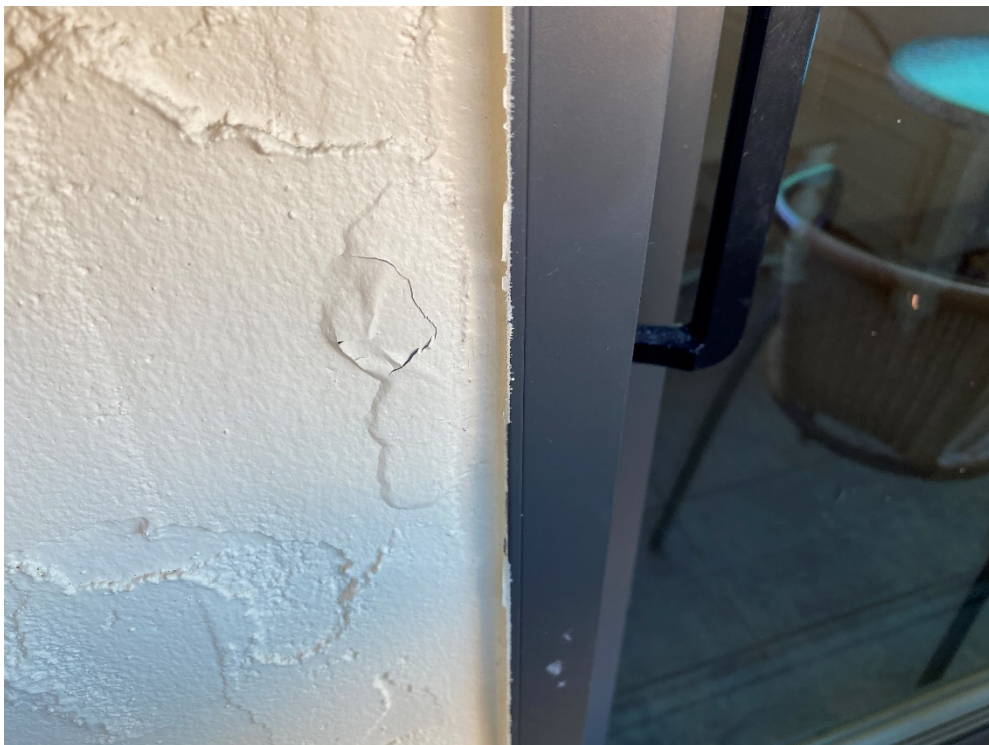
Figure 20. Typical Paint Blister

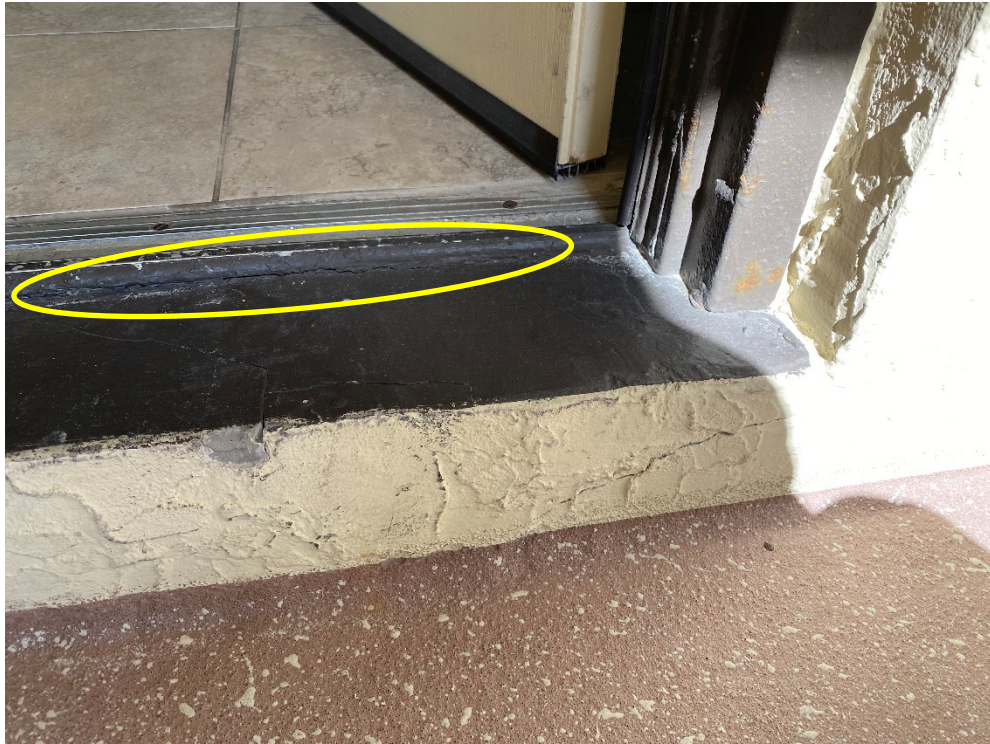
Figure 21. Cracked Sealant

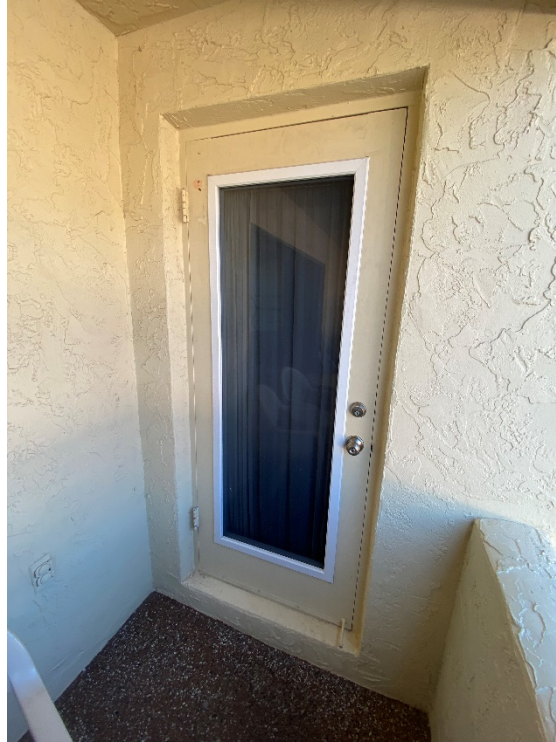
Figure 22. Typical non code compliant single door to access balcony

- KEG recommends having either impacted rated windows and doors or hurricane shutters. KEG recommends going with impact rated SGDs and windows and avoid shutters. Please note that any future alterations to the sliding glass doors and windows will have to be replaced in compliance with the current Florida building code. Units where non-impact rated windows was observed are listed: 405, 306, 308, 307, 309, 209, 206, 205, 201, 102, 104, 108, and 305.

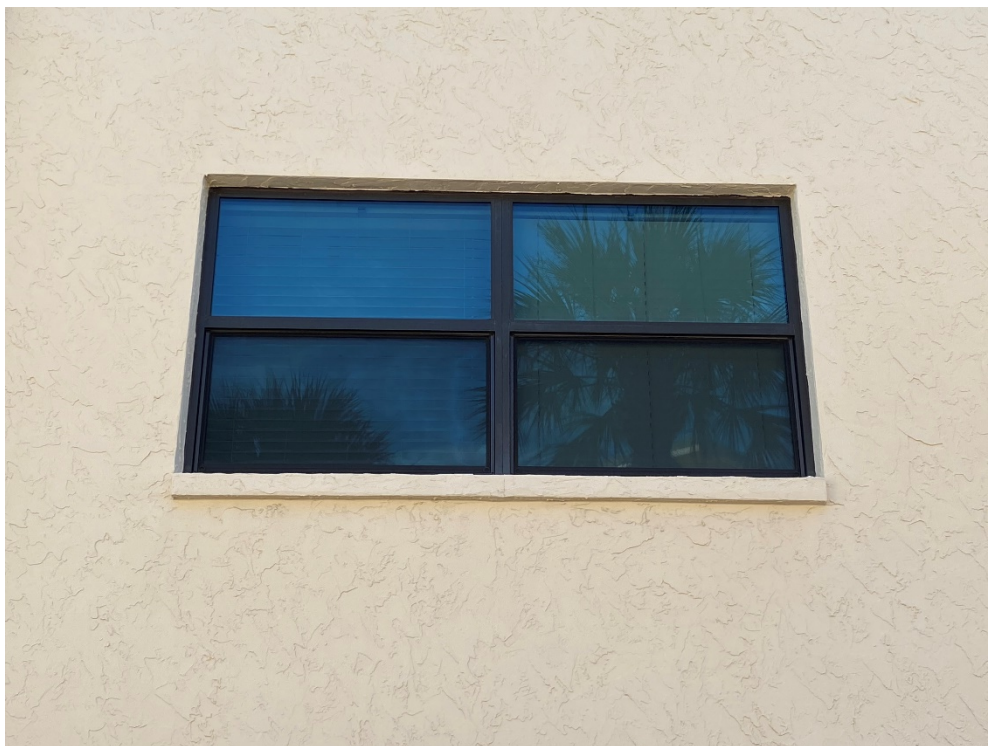
Figure 23. Typical impact rated and code compliant windows

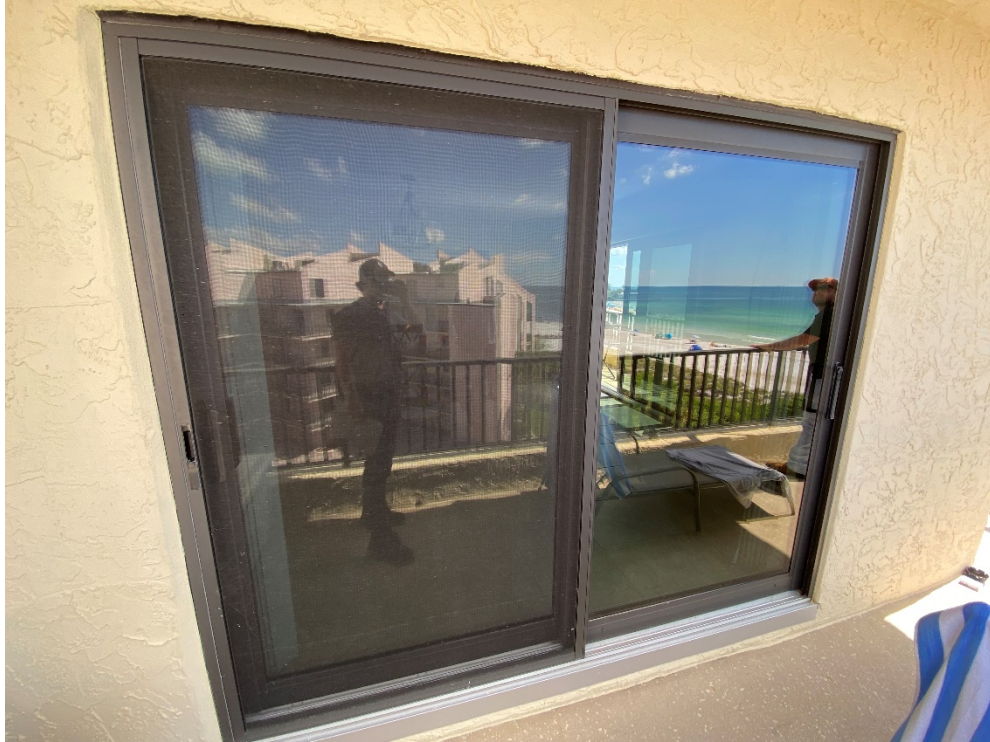
Figure 24. Typical code compliant SGD on balconies

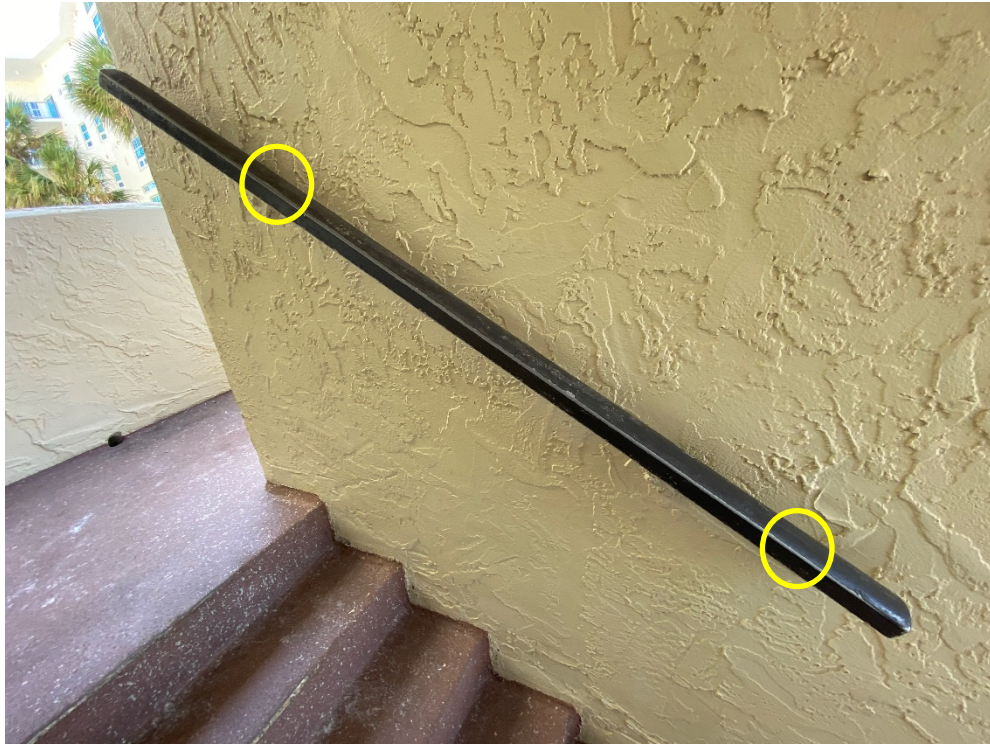
Figure 25. Poor Handrail to wall Connection

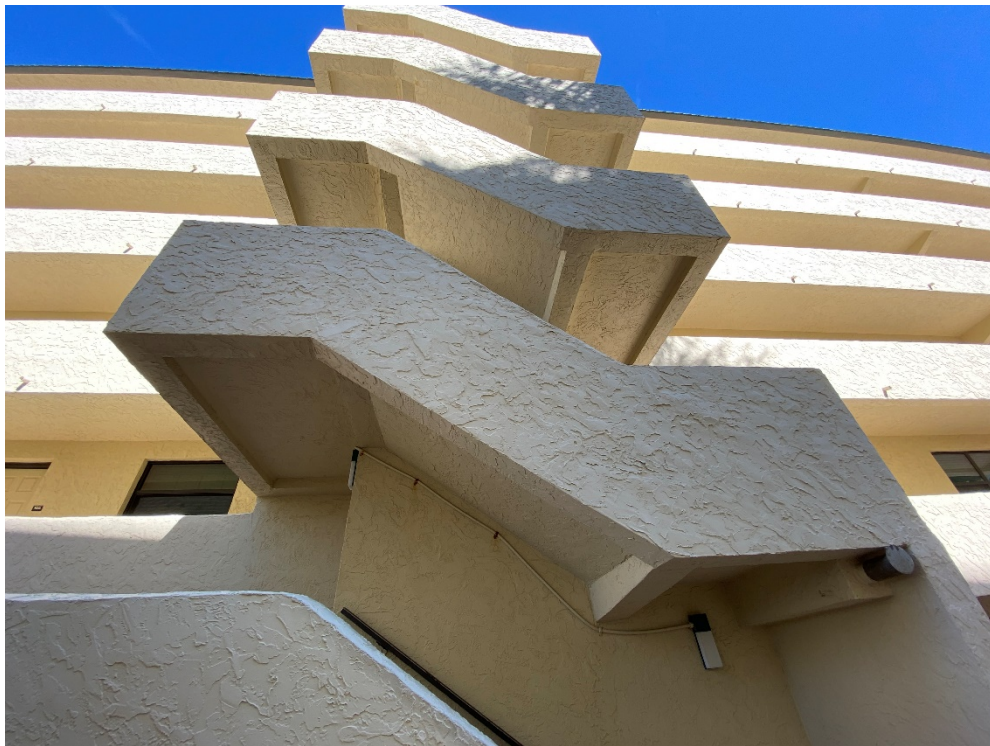
Figure 26. Staircase Railings made on CMU blocks

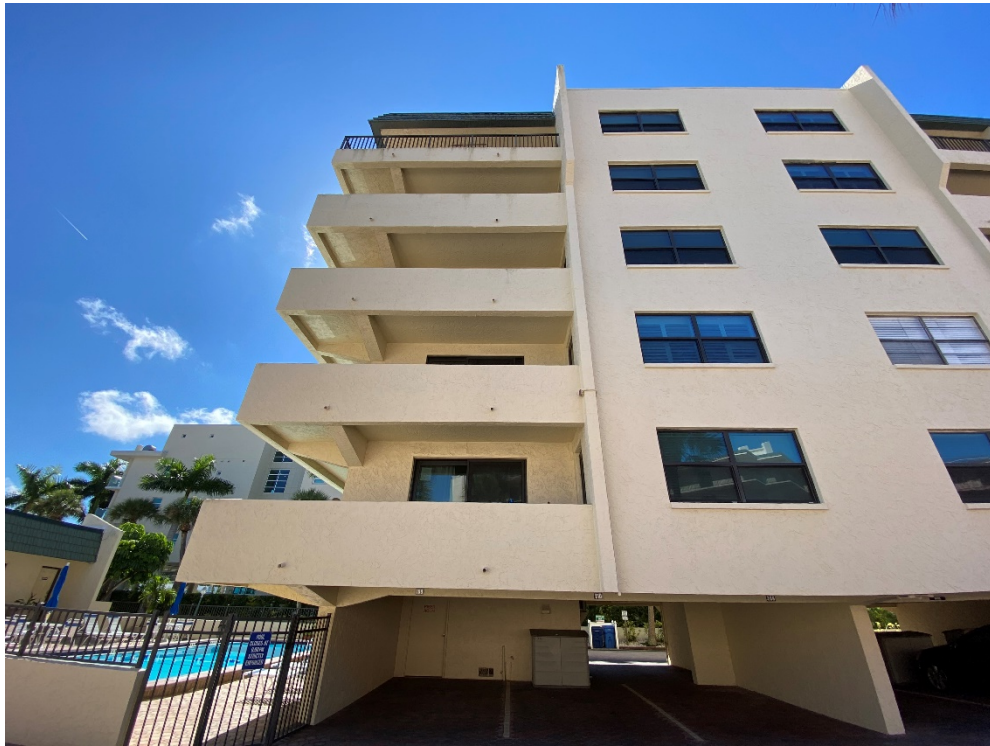
Figure 27. CMU Block Wall on each balcony except last floor

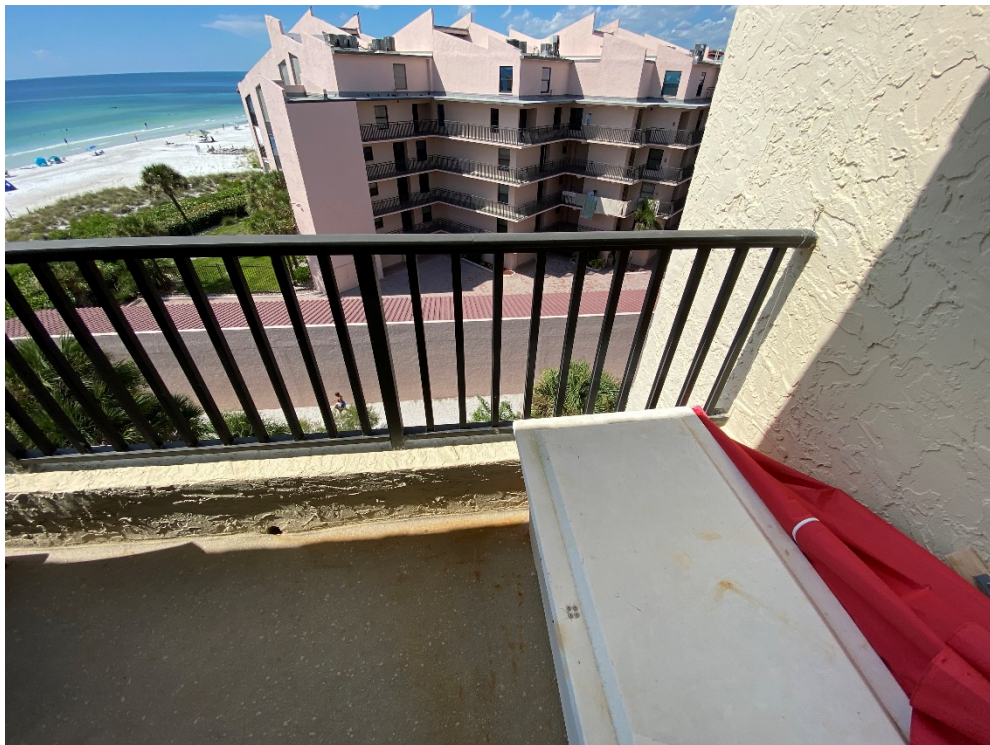
Figure 28. Railings on last floor balconies appears to be up to current code

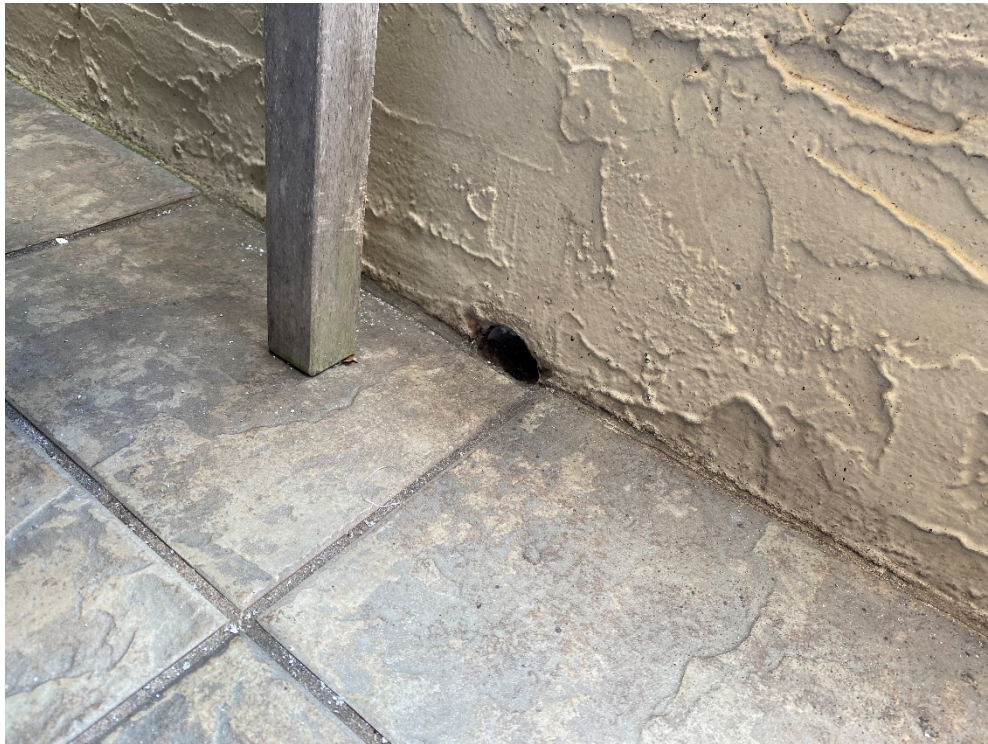
Figure 29. Overflow scupper at balconies obstructed by tiles

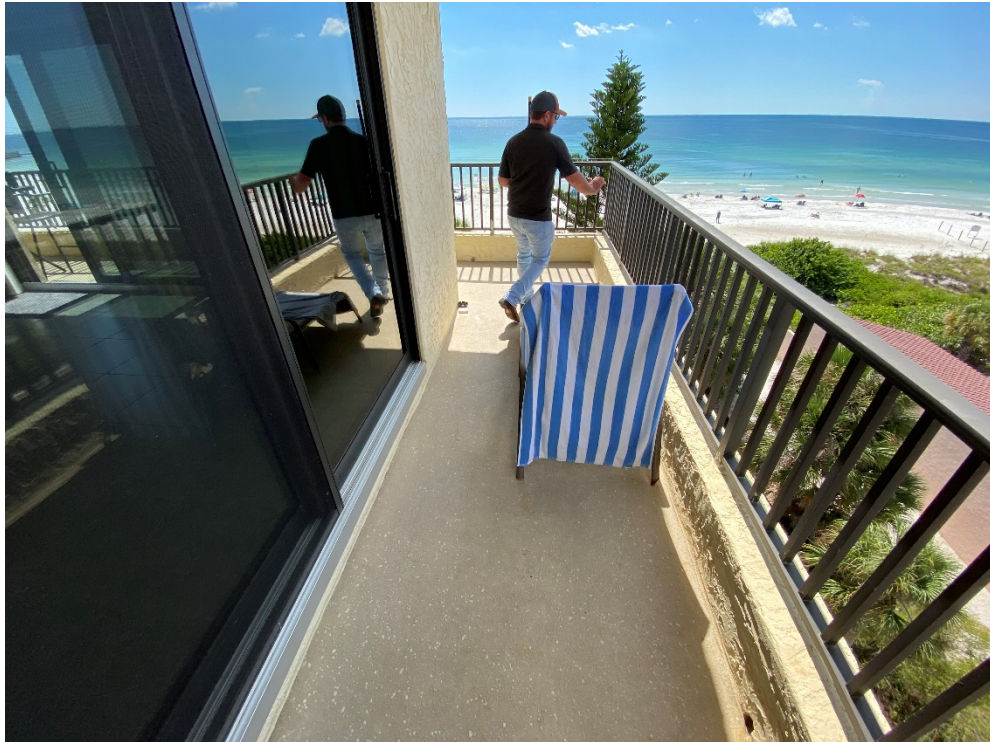
Figure 30. Typical Balcony on last floor with membrane
