Structural Assessment – Existing Condition Report

Project #21RS-0851
February 16th, 2022

*Sea Shell Condominium Association,
Inc.
6500 Midnight Pass Road
Sarasota, FL 34242*

*RE: Sea Shell - Existing Condition Survey
6500 Midnight Pass Road, Sarasota, FL 34242
KEG File# 21RS-0851*

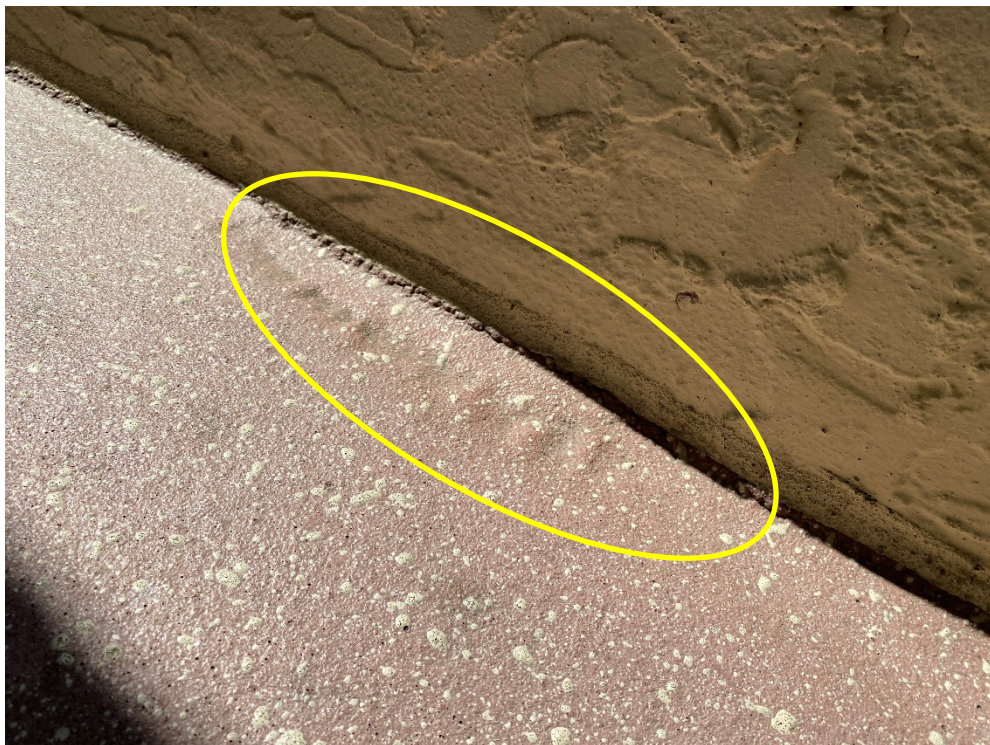
Figure 31. Blistering of membrane at walkway

4. Areas where moisture builds up between the concrete slab and waterproof membrane along the balconies, walkways, and exterior of the building should be cut open and recoated. These areas are easily identified by a “bubble” or pocket appearance.

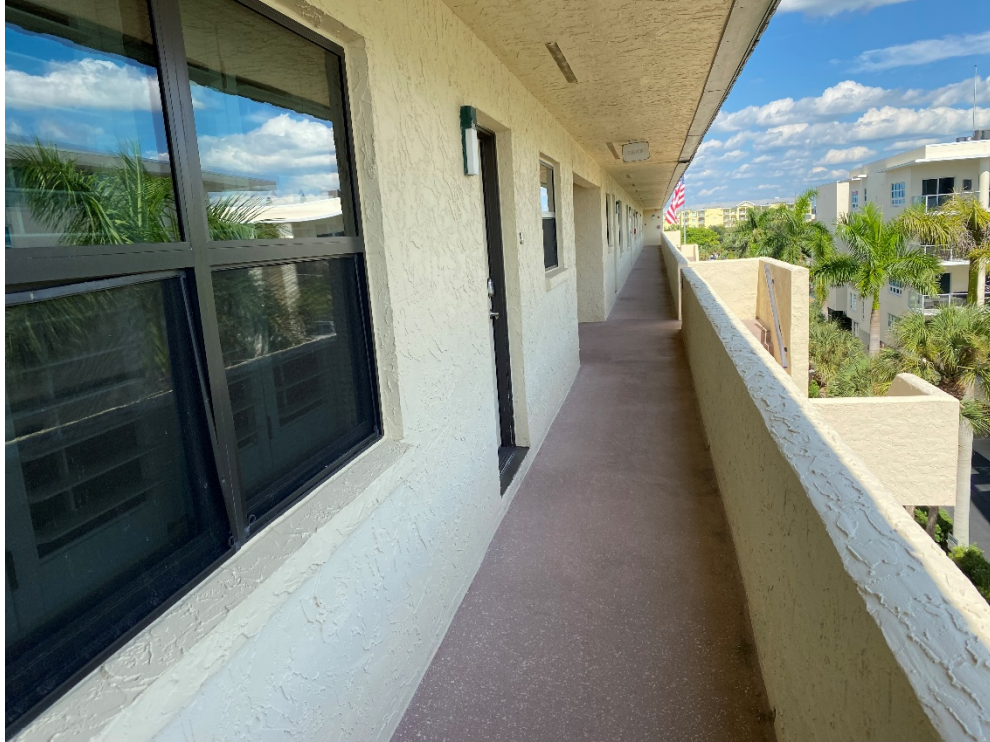
Figure 32. Typical walkway membrane in good condition

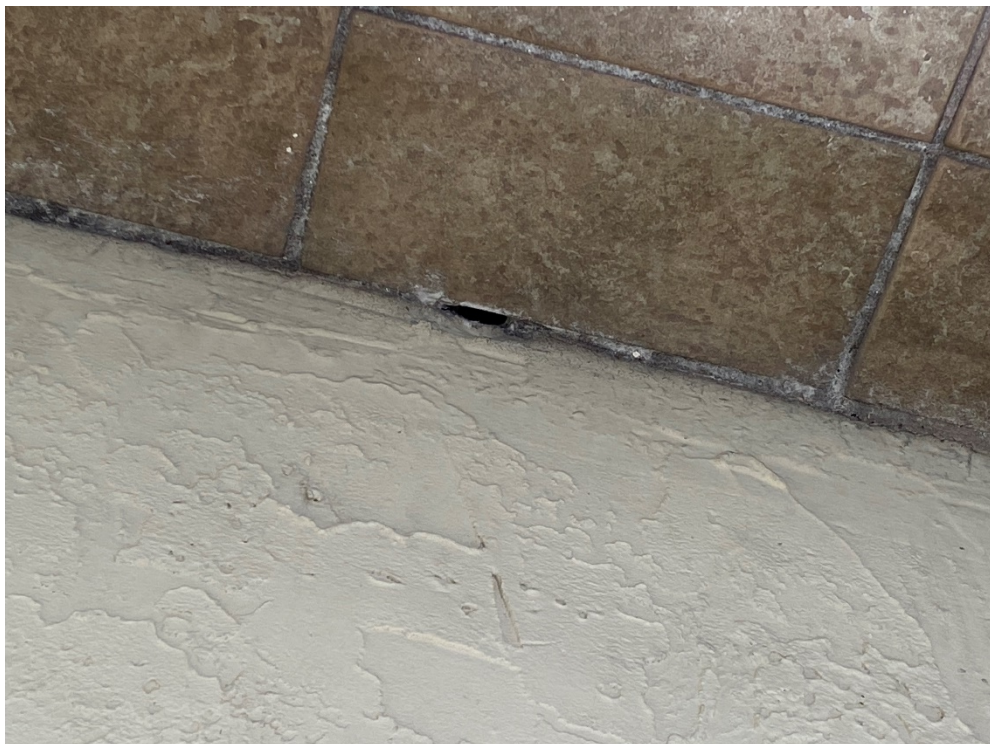
Figure 33. Ponding of water and efflorescence on grout lines

3. KE recommends the following for the balconies:
 - Clean the grout and tiles of all tiled balconies.
 - Apply new membrane finishes along any balconies where the concrete slab is exposed.
